## Safeguarding Cultural Heritage through Technical and Organisational Resources Management

### D9.3: STORM Assessment and Validation Mid-term Report

#### STORM Project

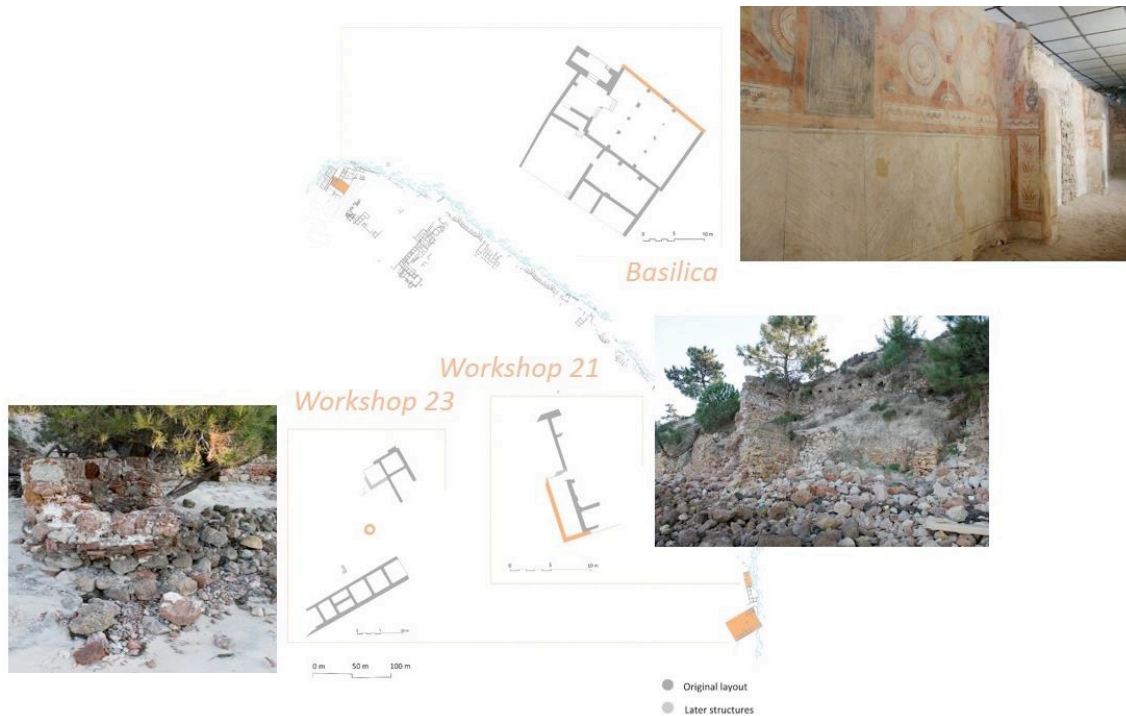
Figure 4: Areas chosen for the application of CEA at the Roman Ruins of Tróia.

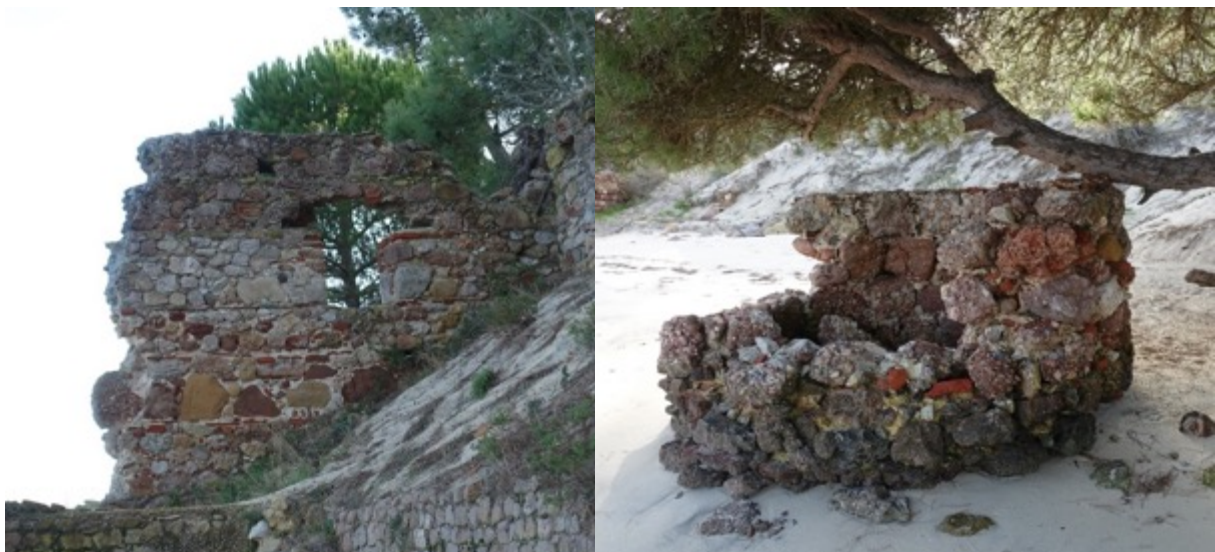
Figure 5: Wall with window in workshop 21 (left) and well in workshop 23 (right).

As mentioned, the shoreline structures are among the most threatened items in the Tróia site. Among these, the structures in Workshops 21 through 23 are the most concerning, largely because they correspond to a relatively large ensemble, including particularly valuable assets, such as one of the tallest walls in any fish-salting workshop in the site, still including a window, in Workshop 21; and the well in Workshop 23 (Figure 5).

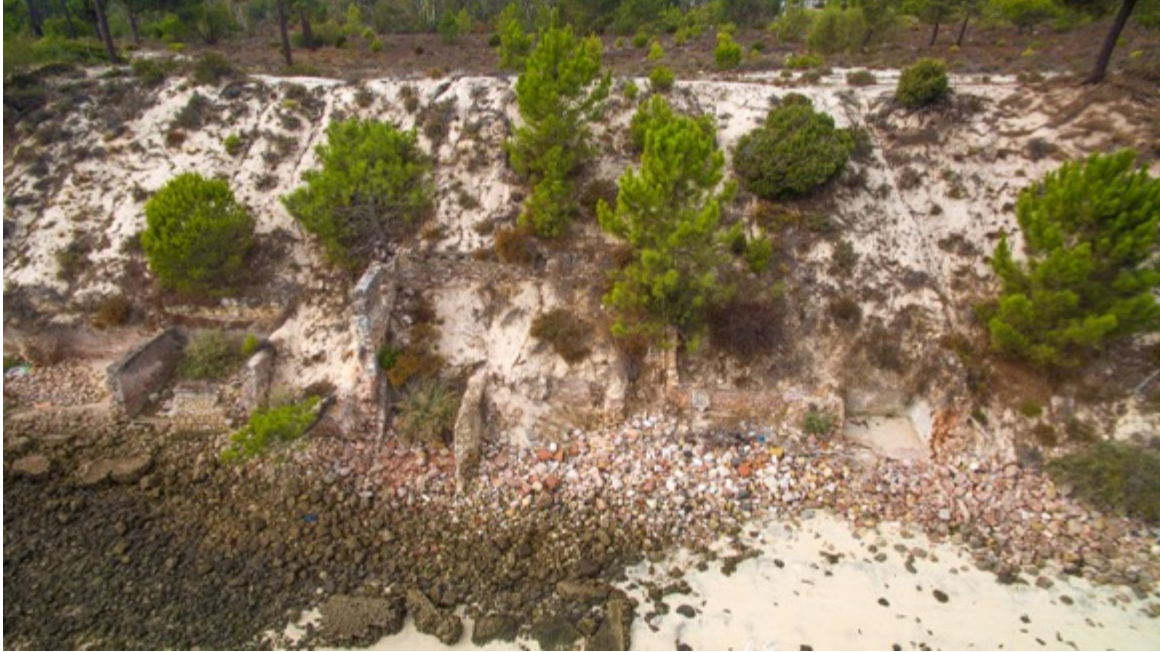
**Figure 6: Shoreline structures of the Roman Ruins of Tróia: Workshop 21 (centre) and partial view of workshop 22 (to the left); the high tide reaches the base of all workshops in this area.**

According to the performed risk assessment, *waves and tidal action*, which (a) have direct physical and chemical impacts upon the structures and (b) lead to *coastal erosion*, also affecting the Roman workshops, are among the most serious hazards affecting the shoreline constructions of the Tróia site. The effects of these hazards upon these fragile structures cause instabilities that can be catastrophically enhanced by *strong winds*, *earthquakes* and/or *intense rainfall*. Furthermore, the progressive dune sand depletion caused by the tides may additionally cause *landslides*.

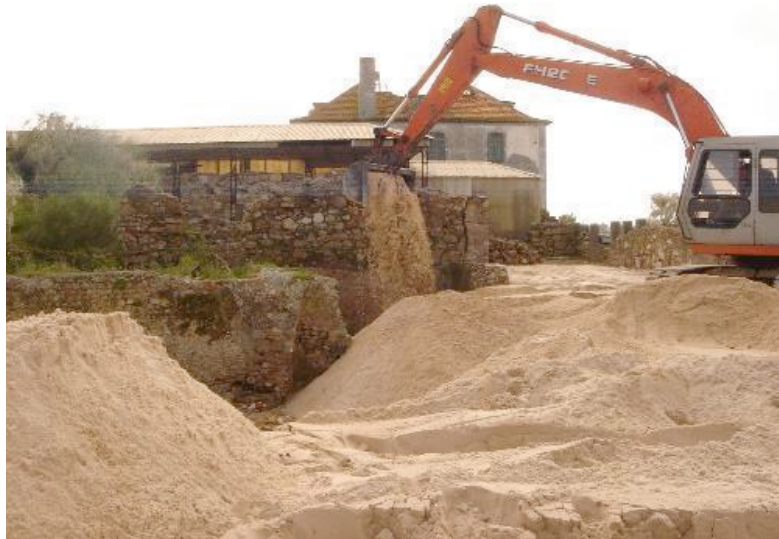
**Figure 7: Beach re-nourishment with reburial of shoreline structures behind the Tróia Basilica.**

The deposit of sand for the re-nourishment of sand-depleted areas has been attempted at Tróia before, slightly downstream from the Workshops 21-23 area, behind the paleo-Christian Basilica (see fig. 7). In 2007, following this sand deposition, which utilised sand dragged from the nearby Marina, many of the archaeological structures were covered in sand, i.e. reburied. In practice, the amount of sand needed for the building of the required beach profile in the area under analysis here would entail the reburial of all shoreline structures.

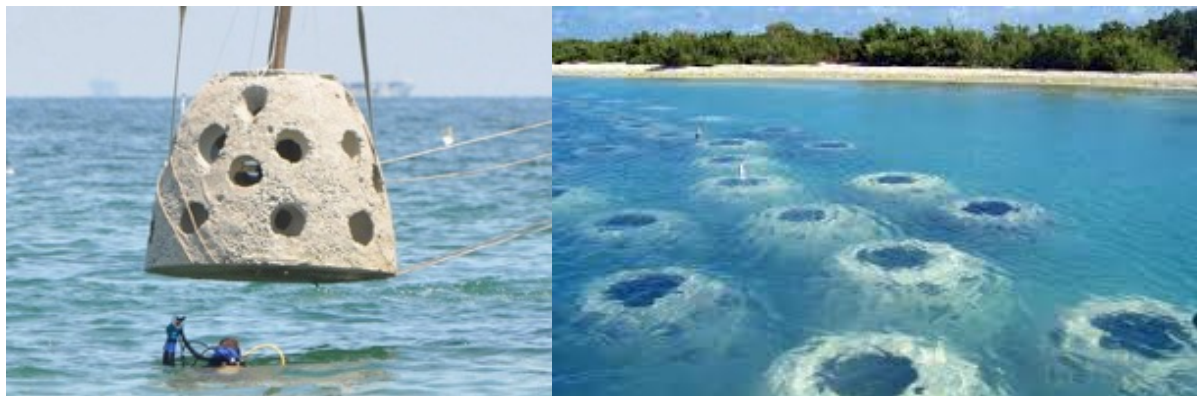
**Figure 8: Examples of reef ball systems deployed in Italy. Sources: [www.ilrestodelcarlino.it](http://www.ilrestodelcarlino.it) (left); [www.reefballitalia.it](http://www.reefballitalia.it) (right).**

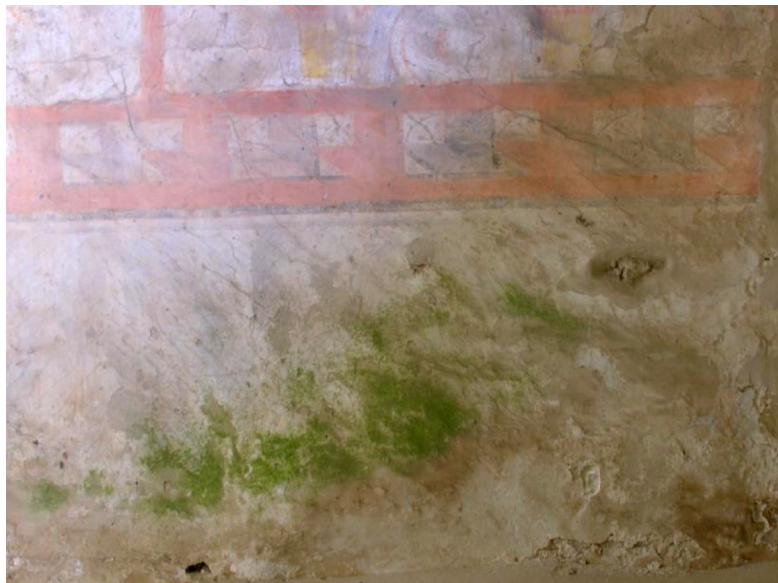
**Figure 9: Algae in Wall c in the Tróia Basilica, before biocide application.**

In the Northeast wall, where some of the most valuable Basilica frescoes are located, biological colonisation can be particularly damaging; the early detection of developing biofilms may prevent that damage by enabling more timely treatments. Walls *a* through *c* (in the Northeast wall) underwent sequential conservation campaigns, generally in post summer months, between 2012 and 2016. At the time of their respective interventions a biocidal product was sprayed on the frescoes, with an expected durability of ~1 year.

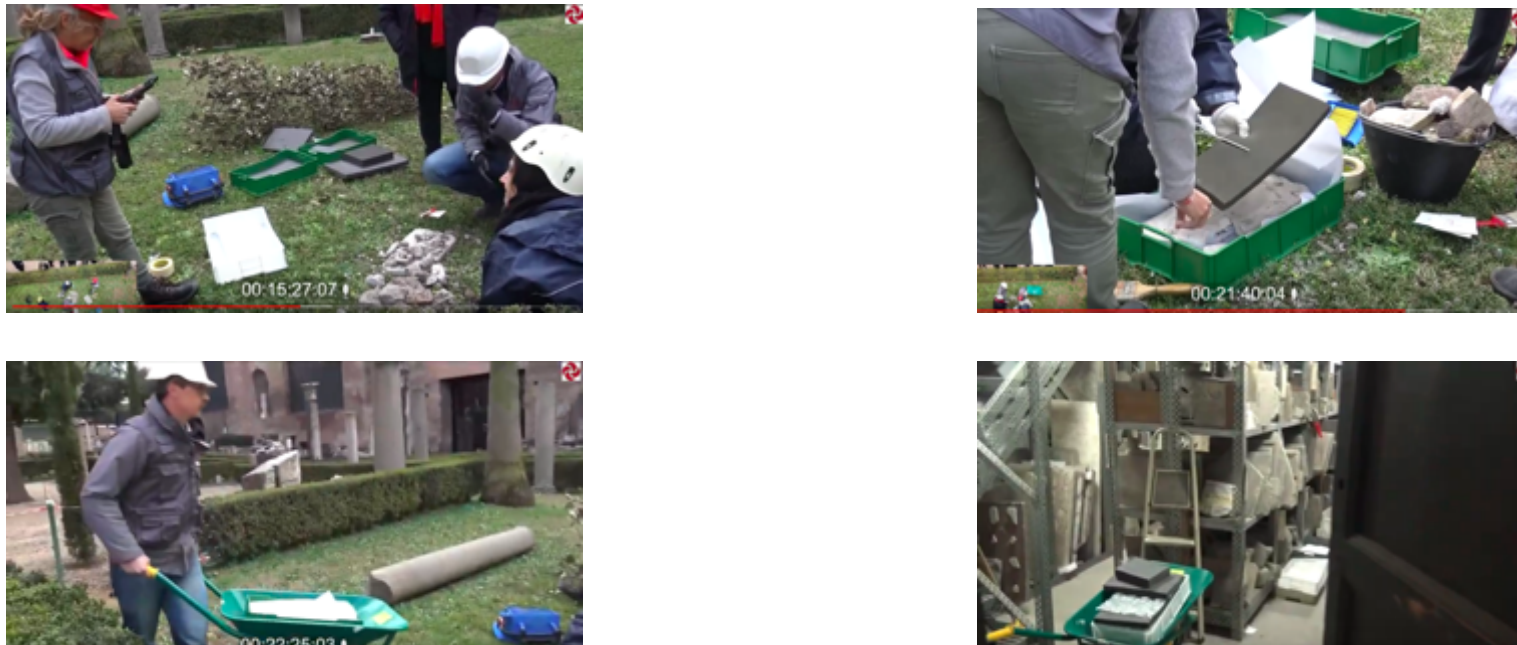
Figure 10 - BOD DRILL 1

Planned recovery	full Cleaning of the surface, re-composition, consolidation and gluing of the fragments, reintegration of the missing parts.	On hold of intervention. The plan was prepared according to the defined recovery principal

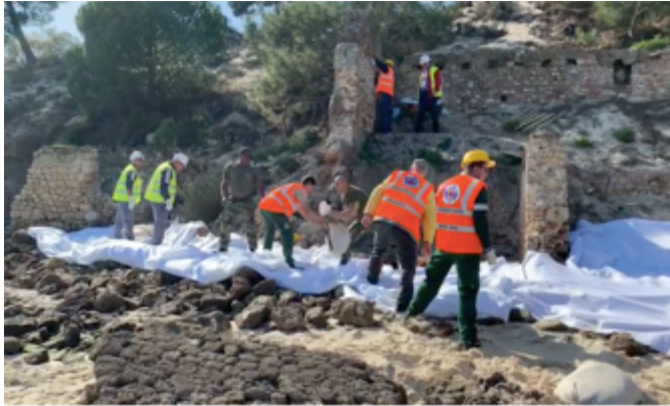
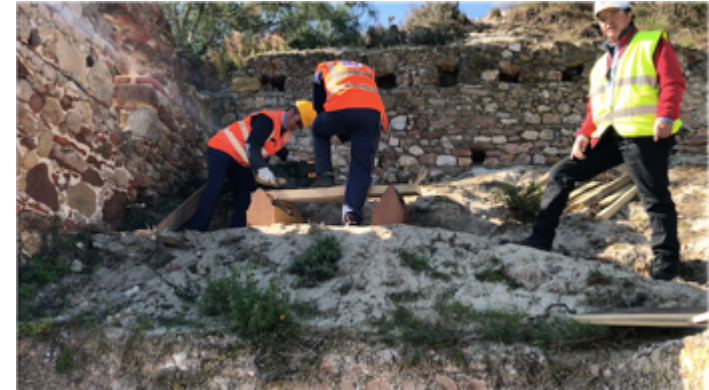
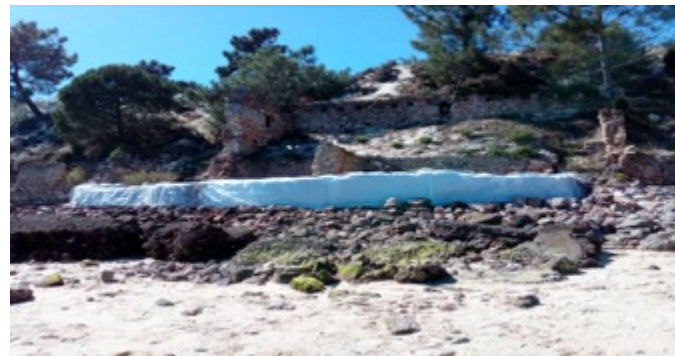
Figure 12 - TROIA Drill 1

<ol style="list-style-type: none"> <li>1. Five operators of the civil protection service install a pipe for the transfer of the sand from the hill to the seashore where the archaeological area is located.</li> <li>2. Three of them fill the bags in resistant tissue to protect the base of the southeast wall from the high tide.</li> <li>3. A u-shaped barrier has been erected by the adjacent vat walls (especially the one parallel to the southeast wall) from the wave impact.</li> <li>4. The sand bags are stacked, protected by a geotextile tissue and further wrapped in a metal net (galvanized iron) to improve the impact resistance of the waves.</li> </ol>	<p>Shoring with wood by carpenters from the region and local dune sand used in the sandbags (bags in plastic). The window frame is tightly held by the shoring, no element loss.</p> <p>Tides are not reaching the wall; the goal was achieved.</p> <p>No secondary damage created by First Aid. Materials were compatible with the execution techniques, and the original material as actual shape have been respected.</p> <p>The not permanent character of intervention takes in account the site located in a natural park trying not to interfere with the shape of the costal skyline.</p>

<b>Securing</b>	n/a	n/a
<b>First Aid</b>	n/a	n/a
<b>Planned full recovery</b>	The full recovery will be achieved with the consolidation of the wall structure through the use of injections and sealing with natural lime mortars the definitive structural consolidation of the window arch and with the installation of a permanent barrier to protect the walls from the tides.	<p>Sandbag barrier was completed in March 2019.</p> <p>The plan was prepared according to the defined recovery principal including new prevention actions The time frame is in line with the overall recovery strategy</p>

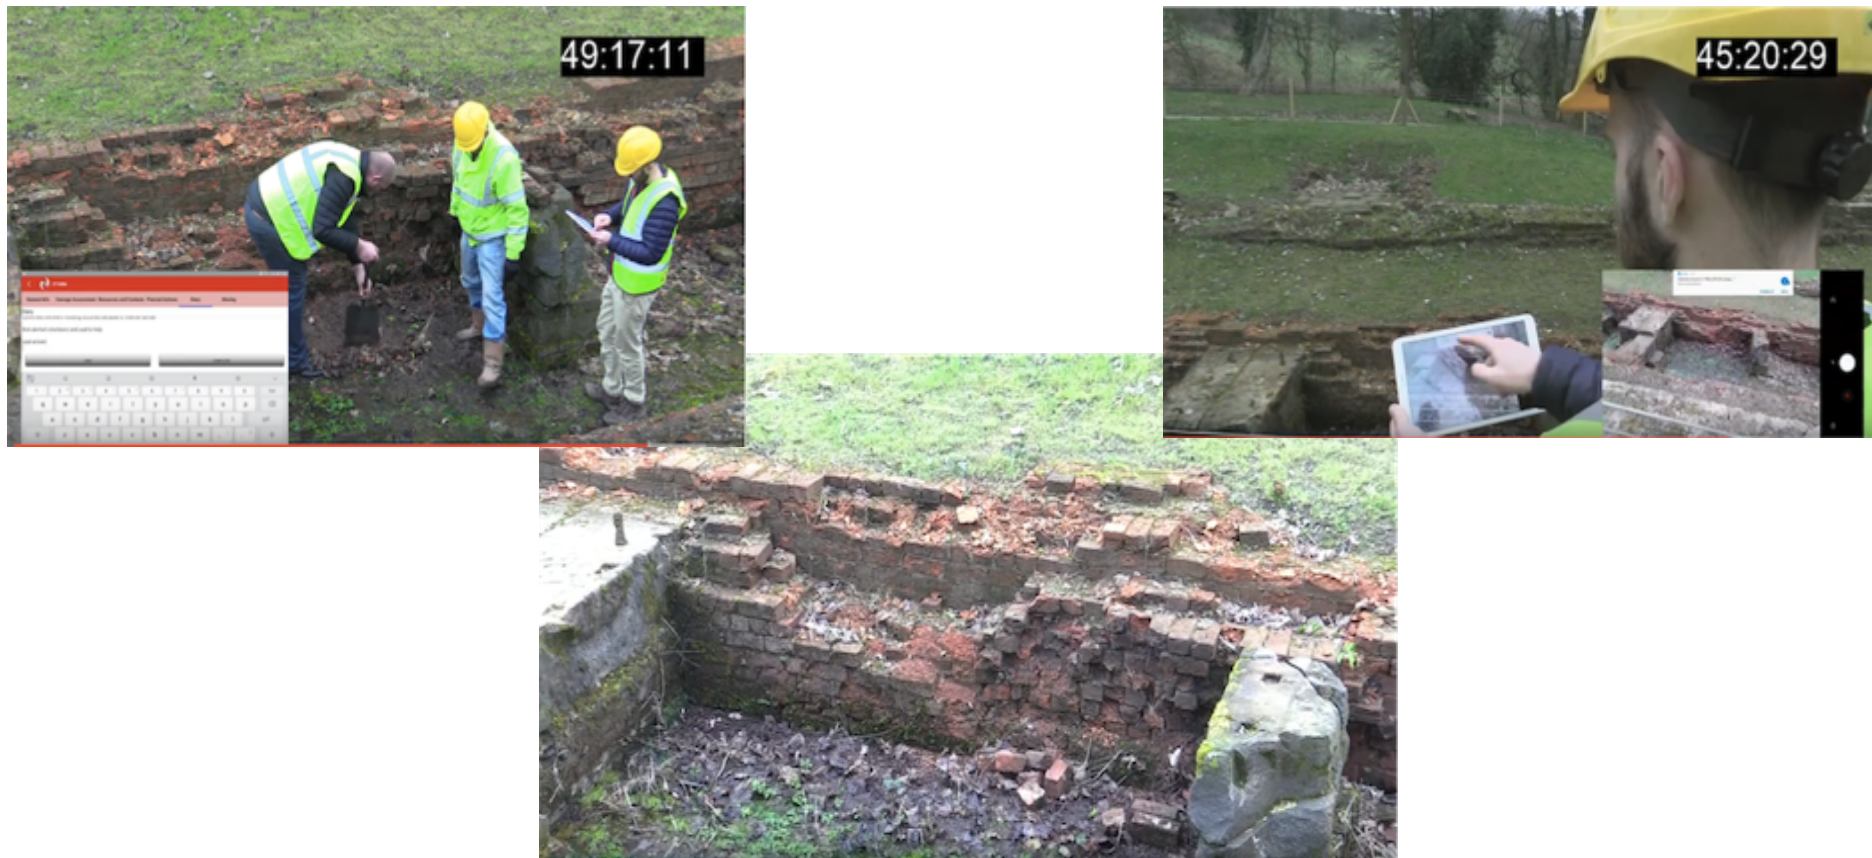
Figure 13 - MELLOR Drill 1

<p><b>Planned full recovery</b></p>	<p>Archaeologists assess the state of the item and decide whether sections of the wall need to be taken for further analysis and how the remaining section of wall can be restored. Assessment of the bricks included analysing the</p>	<p>Still on going.</p>

brick for treatments to make the brickwork more water resistant. The samples were despatched to Spain for testing. This was to test multiple coats of different products could be applied to protect ceramic (handmade bricks) in humidity exposed environments.

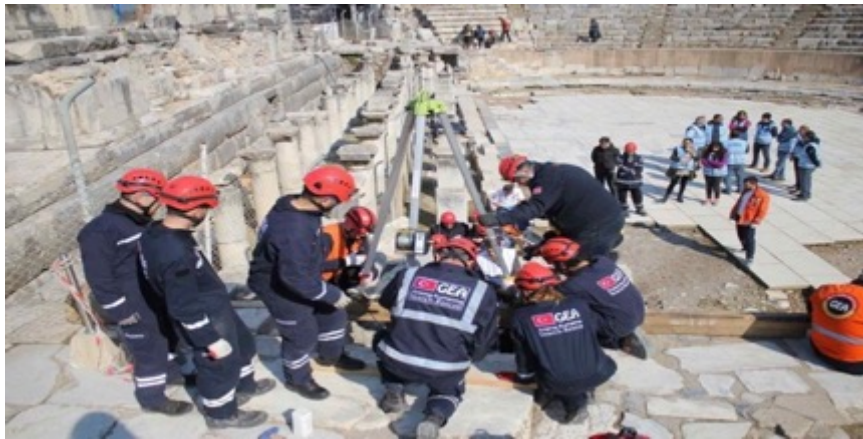
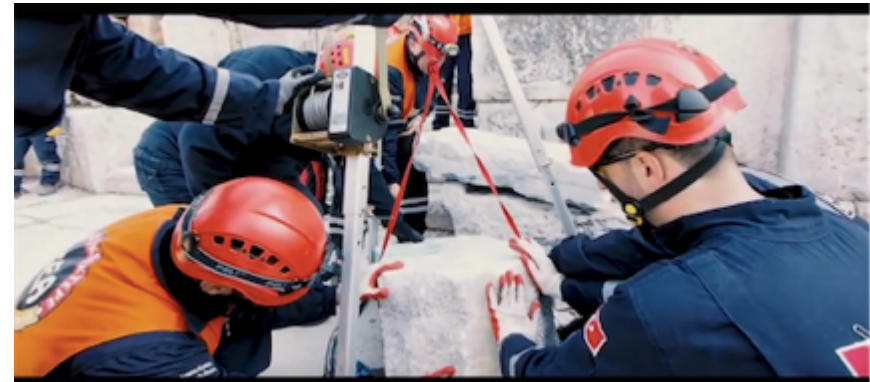
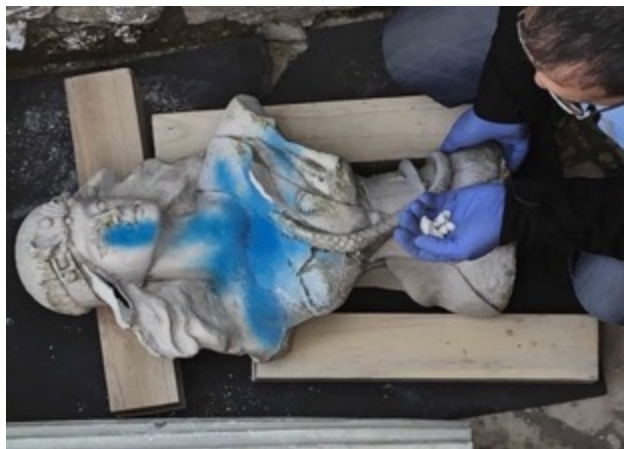
Figure 14 - EPHESUS Drill 1

<p><b>First Aid</b></p>	<p>An early warning alarm signal has been produced within seconds after the occurrence of the earthquake and automatically sent to the platform; the Site manager advice the Team leader that activates the task with SMS message.</p> <p>Team leader convened by the Site manager activates the task by consulting the specifications indicated in the preparedness phase, access routes for the arrival of the equipment and means for lifting and moving the large and heavy stone elements. In the preparedness phase were previewed the transport of manual gantry tripod equipment already available on the site.</p> <p>The bags for transport of non-heavy elements; labels for numbering.</p>	<p>Not extraneous or not compatible elements with the ancient material were employed.</p> <p>The tools already prepared on site and the use of consolidated practice in the management of the earthquake emergency permitted that emergency has been resolved in very fast period as for people involved as for the moving of the ancient stone.</p> <p>The Stone were transported manually and with use of safety bags.</p>

<p><b>Planned recovery</b>     <b>full</b></p>	<p>Extension of the ongoing restoration works.</p> <p>Consolidation of stone cracks; relocation of the element with adequate coupling pins and reinforcement structures; Cleaning; bonding of little parts with compatible materials with the original; integration of the missing part; grouting joint and infill of lacunae.</p>	<p>On hold of intervention, the plan was prepared according to the defined recovery principal including new prevention actions. The time frame is in line with the overall recovery strategy</p>

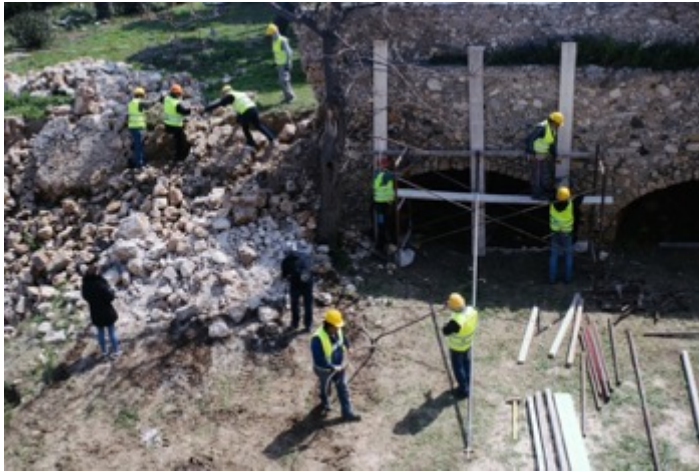
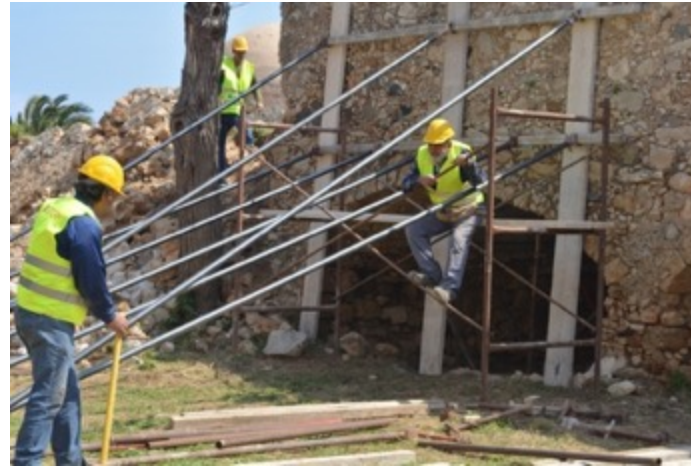
Figure 15 - EFARETH Drill 1

<p>Then starts the removal of the falling stones followed by the selection of the best preserved ones in order to use them again for the reconstruction of the wall.</p> <p>With precaution the excavation grid has been used to mark the exact original area that each stone was removed from. The stones have been labelled and documented.</p> <p>The drill ends by setting the third part of the scaffolding at the south part of the wall.</p>	
<p><b>Planned recovery</b>    <b>full</b></p>	<p>The full restoration plan for the double hall cannon wall includes the following steps:</p> <ul style="list-style-type: none"> <li>- Reconstruction project.</li> <li>- Gap filling on the preserved walls with stones similar to the ones in the masonry.</li> <li>- Grouting with appropriate lime mortar on the masonry of the arches of the cannon halls.</li> <li>- Gap filling/restoration of the masonry that collapsed with appropriate stones (the ones collected in situ and belong to the original masonry). The rubble stones will be cleaned mechanically from damaged mortar.</li> </ul>	<p>Ongoing process.</p> <p>The plan was prepared according to the defined recovery principal including new prevention actions. The time frame is in line with the overall recovery strategy</p>

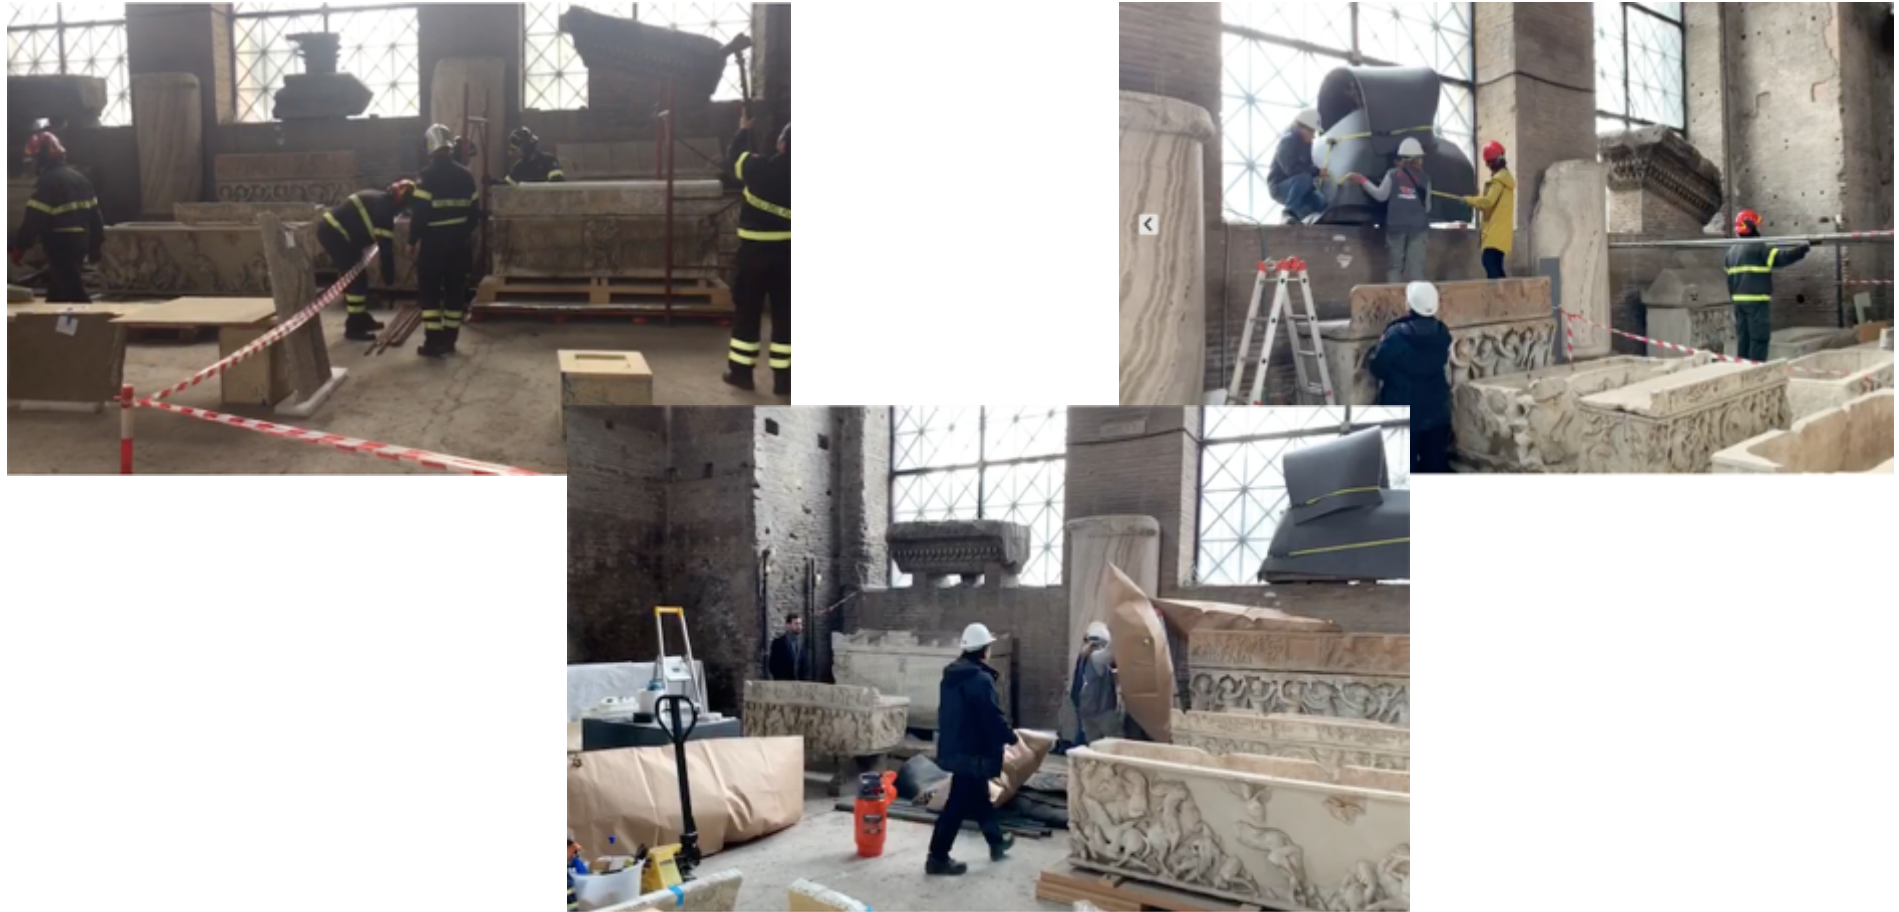
Figure 16 - BATHS OF DIOCLETIAN Drill 2

<p><b>First Aid</b></p>	<p>The team leader provides instructions to the team; after evaluating the level of danger he decides not to move the works.</p> <p>Among the options offered by Preparedness on the app there is the possibility of bringing a trans-pallet from the warehouse and moving some items.</p> <p>The risk of damage can also be mitigated by leaving the works on place and by protecting them with absorbent bump material.</p> <p>The resources on the app show the availability of: a cylinder for transportable compressed air on site, airbag inflatable cushions (<i>Cocoon Packaging system</i>), ratchet straps and equipment for a first aid in the event of fracture or detachment of parts.</p> <p>The team organizes the intervention: two operators take the material stored in a dedicated area, while they begin to inflate the cushions; two of them also carry other materials such as Ethafoam.</p> <p>During the operation some photos are taken, and the intervention diary is written in real time on the mobile app.</p>	<p>The inflatable cushions are composed of an inner polyethylene bag (40gr / m<sup>2</sup> approx.) covered externally with one or more layers of water-resistant Kraft paper (80gr / m<sup>2</sup> approx.), this ensures the robustness of the inflatable cushion even when subjected to strong stresses.</p> <p>They are born for the packaging and transport of fragile products of various kinds, a light, safe and very economical protective system, and they are reusable after deflation.</p> <p>They reduce, when emptied of the air, the problem of storage space, as they are very thin and light to carry; the polyethylene film is internal and the quantity is such as to be considered environmentally friendly.</p> <p>The Preparedness provides for the use of silent transportable cylinders that can be used in conditions of absence of electricity.</p>

<p><b>Planned recovery</b></p>	<p>full Brushing of the surface.</p>	<p>To be done.</p>

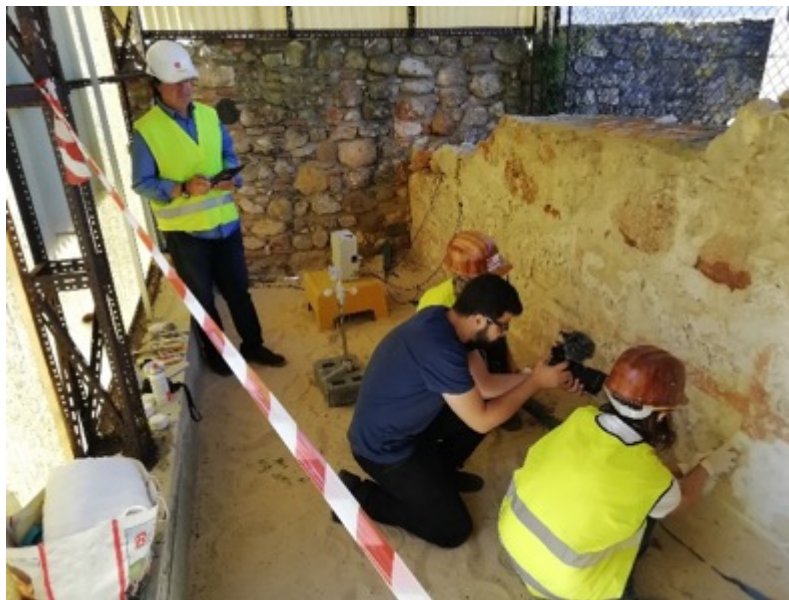
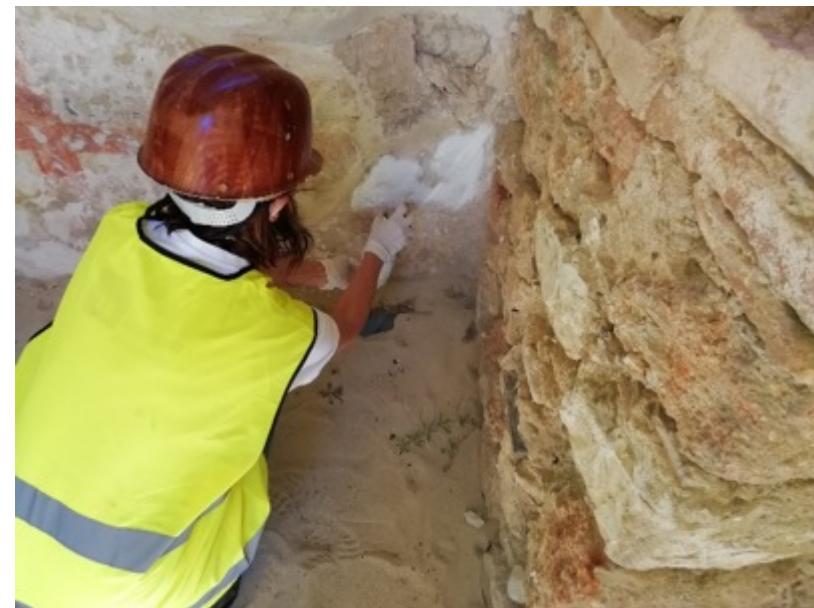
Securing	n/a	n/a
<b>First Aid</b>	<p>The access to the wall area was limited using emergency tape, the area was secured to restrict access from all those not involved in the heritage first aid actions.</p> <p>To face the fragility and potential loss of wall painting, an immediate intervention was decided for stabilizing and reinforcing the artefact. The decision fell on the application of the temporary consolidant.</p> <p>Cyclododecane in spray. It was sprayed to the most fragile painted surface interested by powdering flaking of the fresco paintings.</p> <p>The whole procedure was thoroughly documented via STORM platform and app; photocamera; and video camera.</p>	<p>One of the best preserved monuments of the archaeological site of Tróia is the Paleochristian Basilica, a church built at the end of the 4th century or the beginning of the 5th century.</p> <p>The damaged wall still bears many parts of fresco-painted surfaces. The chosen product and application method were adequate and the best practices in conservation followed, preserved a most famous post classical era (5<sup>th</sup> century AD) frescoes, incredibly preserved though located in an area with a high microclimatic risk for their conservation. The frescoes in this wall are among the most fragile and damaged of all the Basilica wall paintings.</p> <p>The used consolidant is of low toxicity, and sublimates without residue on the original materials; it is considered of low environmental impact.</p> <p>Roman execution techniques were respected, this product is temporary but highly effective for the very thin painted layers. The frescoes were protected without further damage for the originality of the materials and techniques.</p> <p>The painting is sufficiently stabilized and will hold until a more effective conservation intervention can take place, the undertaken first aid actions do not prevent nor will interfere with a more effective and detailed conservation intervention.</p> <p>Edging repairs in some intonaco areas, performed in the ~1980s, did not show signs of decay and were not affected by the First Aid intervention.</p> <p>This first aid solution is transferable to other fragile heritage surfaces facing similar threats. Given the characteristics of low</p>

<p>toxicity, easy and quick application, low environmental impact sublimation without leaving residues, it can also be extended to other surfaces, without any impact on the natural environment in which they are stored.</p>
<p><b>Planned recovery</b></p>	<p><b>full</b> Starting from the environmental control, it is necessary to program as soon as possible a more effective conservation action to guarantee the preservation of the structure and the frescoes decorated surface. The intervention previewed is structural consolidation with injection of grout, fixing flakes and fragments of painting layers, micro-fillings and grouting, salt reduction, cleaning and protection are to be considered.</p>	<p>Already in programming.</p>

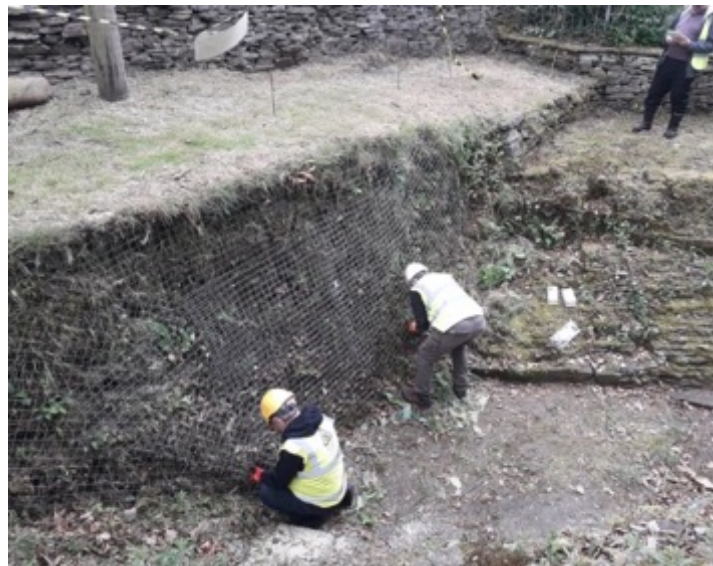
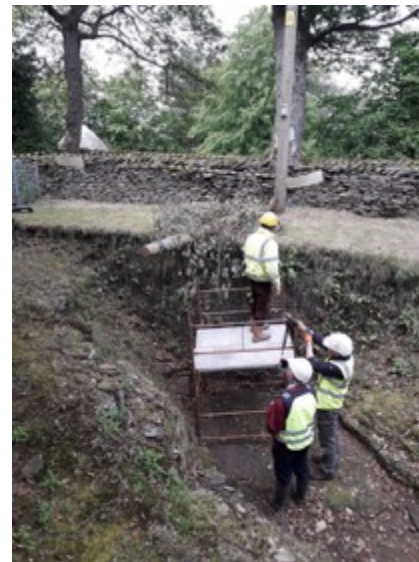
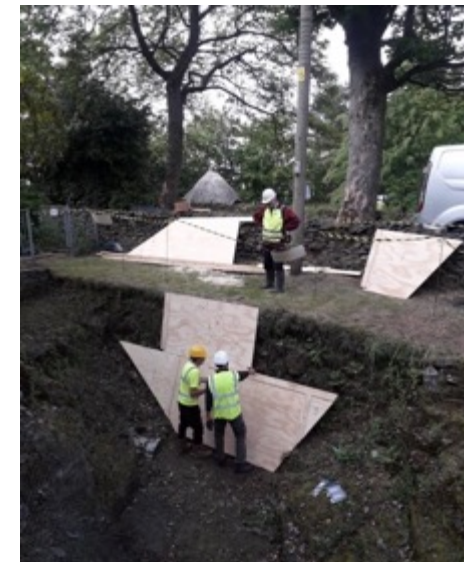
Figure 18 - MELLOR Drill2

<p><b>Phase</b></p>	<p>Description</p>	<p>Efficacy</p>
<p><b>Pre-Hazard actions</b></p>	<p>n/a</p>	<p>n/a</p>
<p><b>Securing</b></p>	<p>The site is cleared of the public. The site is cordoned off to ensure the safety of staff and the general public using hazard tape and warning signs.</p>	<p>This is in line with local procedures because the area in question is open to the public so the need to cordon off the site was reiterated to the land owner and permission granted.</p>
<p><b>First Aid</b></p>	<p>The tree was cut into small manageable pieces and then moved from the archaeology area. Expert arrived with all the tools necessary to do intervention.</p> <p>Weeds were removed from the mesh so that it could be taken away without causing further damage to the archaeology.</p> <p>Mesh was removed revealing the damaged earthworks.</p> <p>Using the dashboard as a collaborative tool, detailed plans of the item could be sent to suppliers so that wood could be cut to size off site and further prevent.</p>	<p>The works were conducted in a way where no further damage could be caused to the archaeology. Experts were at hand to advise.</p> <p>Weeding was useful in general as it improves the state of conservation of the item and is in line with previous interventions.</p> <p>Local tradesmen were used to improve the environmentally friendly and thick local approach of this work. Having the wood prepared offsite and to exact measurements ensured the archaeology surrounding the item could remain as untouched</p>

<p>Use of the STORM app for reporting in the diary and taking photos and videos throughout the first aid process ensured non-experts could respond within the STORM Mellor policies and practises, preventing damage to the archaeology in the installation process.</p>	<p>as possible by the installation of the temporary shoring. Wood was used for its eco-compatibility although a return to the metal mesh is necessary for its long-term durability and cost effectiveness.</p>
<p><b>Planned recovery</b>      <b>full</b></p>	<p>Short term a joiner provided and installed wooden shoring to keep the earthworks in place.</p>	<p>Over the coming weeks, a new mesh will be provided and reinstalled as this has provided 10+ years of stability to the cross section item.</p>

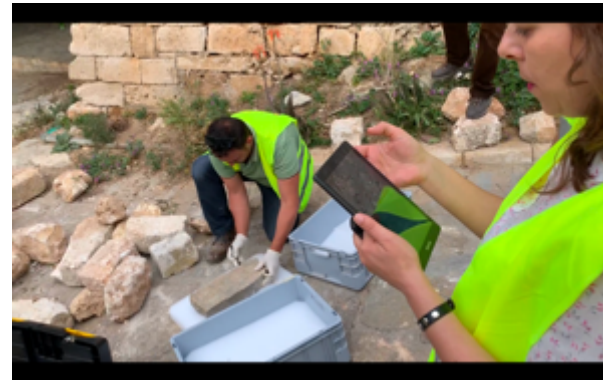
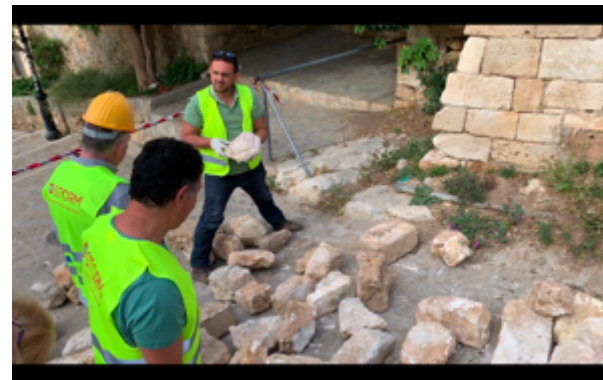
Figure 21 - EFARETH Drill 2

<p>First Aid</p>	<p>When the area was secured and the victims safely removed, the First Aid EFARETH team took action. The site manager together with the responsible archaeologist, civil engineer, conservator and technician inspected the damage and coordinated the documentation and recording, the</p>	<p>The collection/secure transfer or storage of fallen material was carried with minimum use of vehicles and by using reusable boxes. The scaffolding is made by wooden planks and stainless</p>

<p>structural support of the fortification wall and the safe transport of the fallen material.</p> <p>The sculpted stone and the inscription that was found in the collapsed masonry were transferred in reusable boxes and placed over Ethafoam cut in shape to ensure minimum motion. Construction of scaffolding of metal tubes and wooden planks (technicians-restorers, conservator, archaeologist) for temporary structural support of the masonry.</p>	<p>steel rods. The materials are eco-friendly and reusable.</p>
<p><b>Planned recovery</b>      <b>full</b></p>	<p>Two studies need to be prepared by specialists and approved by the Central Archaeological Council, Hellenic Ministry of Culture and Sports.</p> <p>The soil infills of the bastion require stabilization.</p> <p>Restoration study of the watchtower and the part of the collapsed fortification wall.</p> <p>Full architectural documentation/design.</p> <p>The project can consider the re-use of the rectangular stones that were collected from the collapsed part are in good condition.</p> <p>Reconstruction with compatible material (Natural Lime) cleaning and consolidation of areas adjacent to the collapse; use of natural lime for injection and anchoring systems compatible with the ancient structure.</p>	<p>The plan was prepared according to the defined recovery principal including new prevention actions. The time frame is in line with the overall recovery strategy</p>

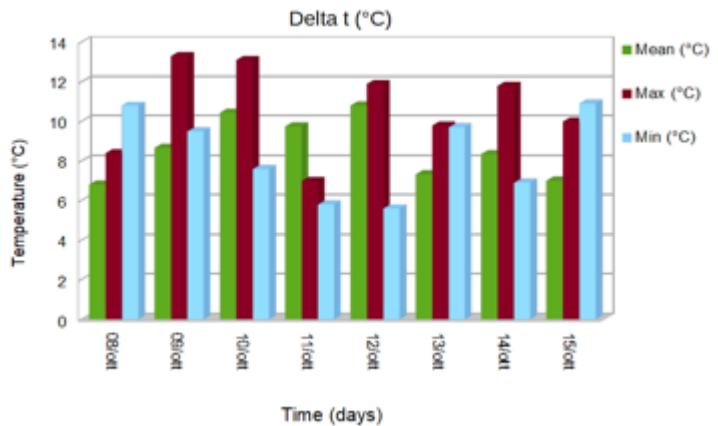
**Figure 23. Temperature differences between the two experimental periods**

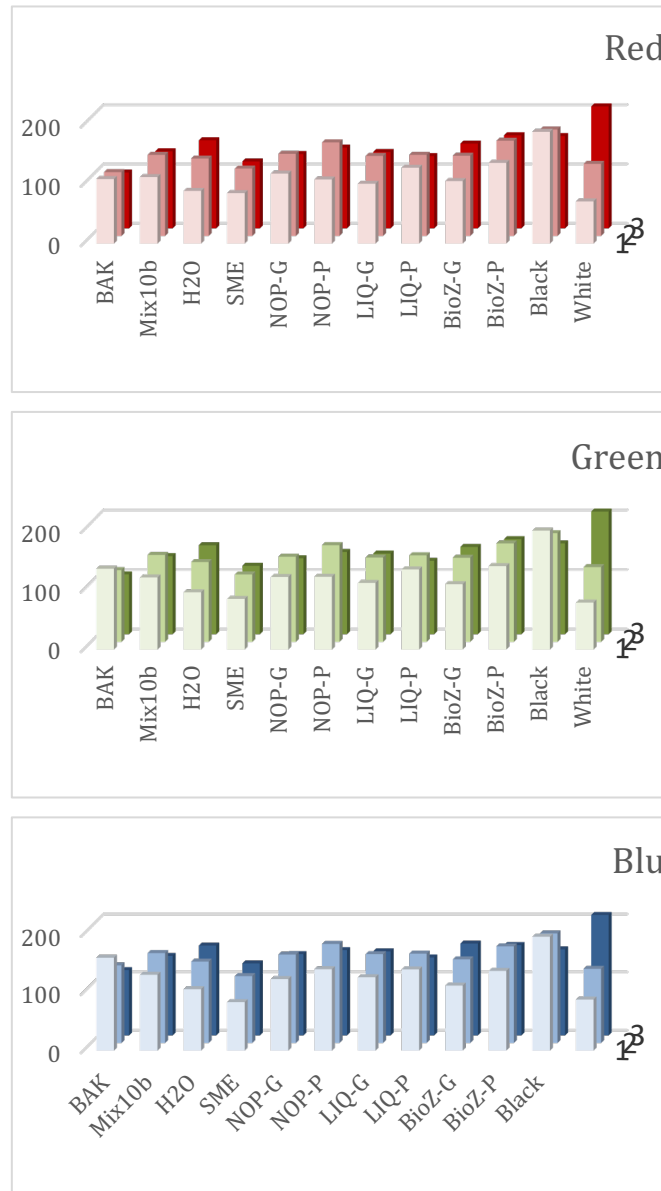
Figure 24. Histograms of the RGB mean values obtained from the photographs rectangular sections related to different exposure times. *Black* and *White* are respectively the most darkening and lightening intensity of not treated surface.

We can obviously observe an important variation of the untreated (white) surface followed by the water (H<sub>2</sub>O) and BioZ-G tests. A slight variation is reported by SME1.11, all the others have a limited change, except BAK (Benzalkonium Chloride), where the decrease in values indicates a reduction in the initial yellowing.

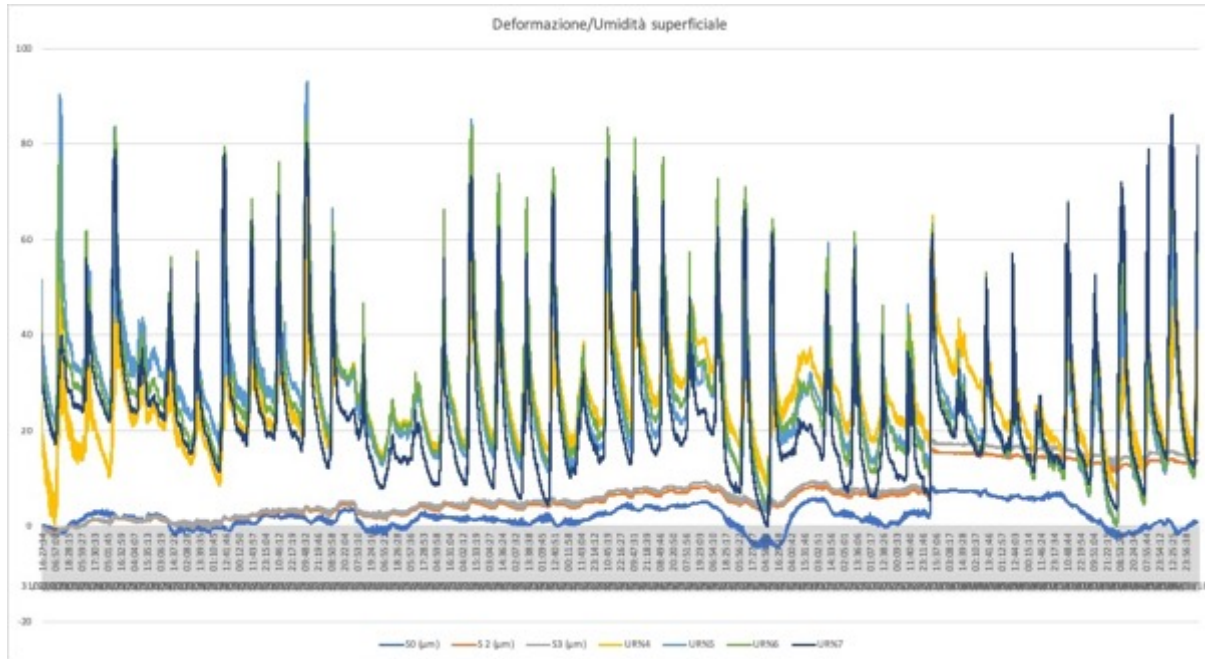
Figure 27 Trends of the value recorded both inside and outside Hall I by FBG sensors (October 2017- June 2018)

A high presence of humidity on the masonry, and the sudden variations of it, recorded during this period, are certainly dangerous for conservation purposes. The continuous decrease of humidity can cause, in fact, the appearance of salt efflorescence, while increase of humidity can cause biogrowth, presence of algae and, above all, detachment of the plaster covering the masonry.

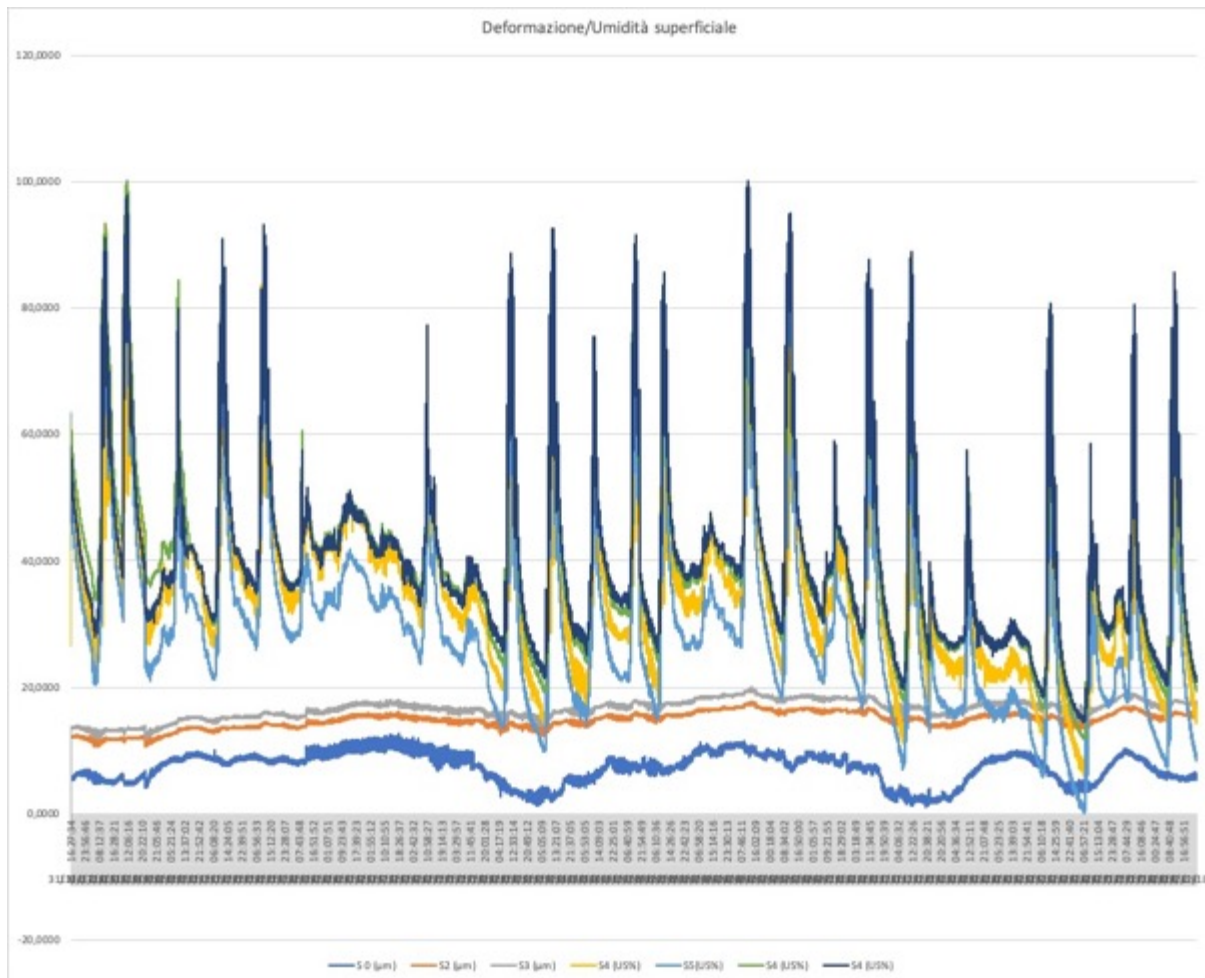
Figure 28 Trends of the value recorded both inside and outside Hall I by FBG sensors (October – December 2018)

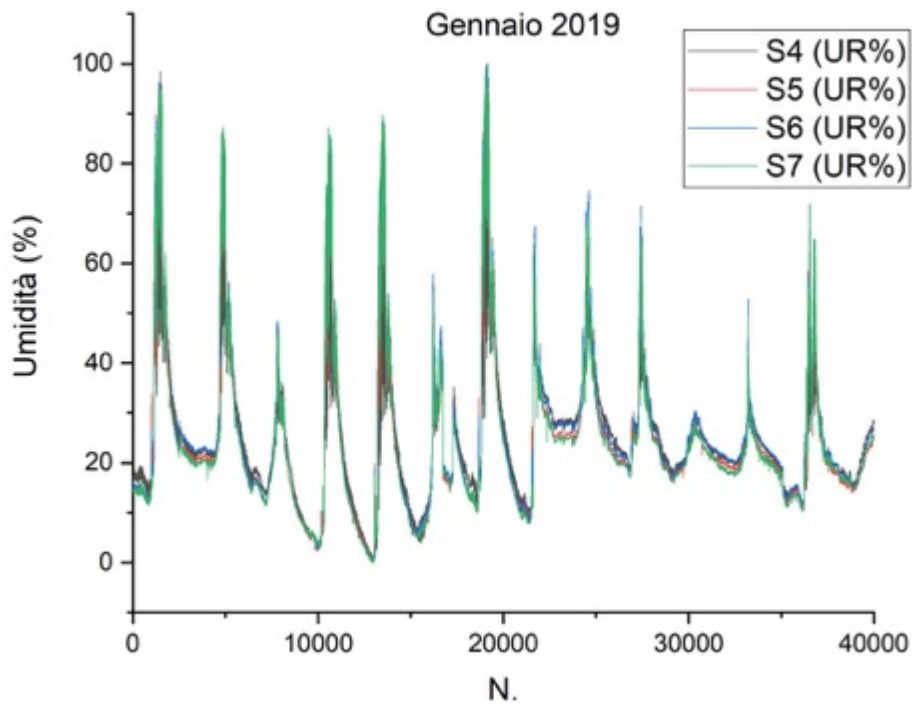
Figure 29 Trend of the Rising humidity recorded outside Hall I in January 2019

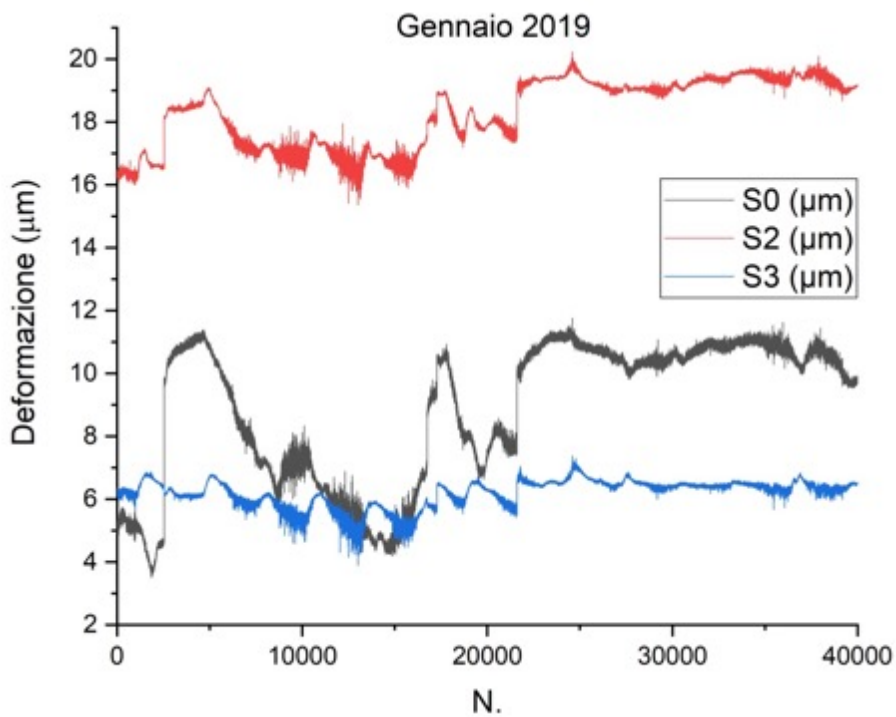
Figure 30 Trend of the strain recorded by FBG sensors inside Hall I, January 2019
