## Safeguarding Cultural Heritage through Technical and Organisational Resources Management

### D9.3: STORM Assessment and Validation Mid-term Report

#### STORM Project

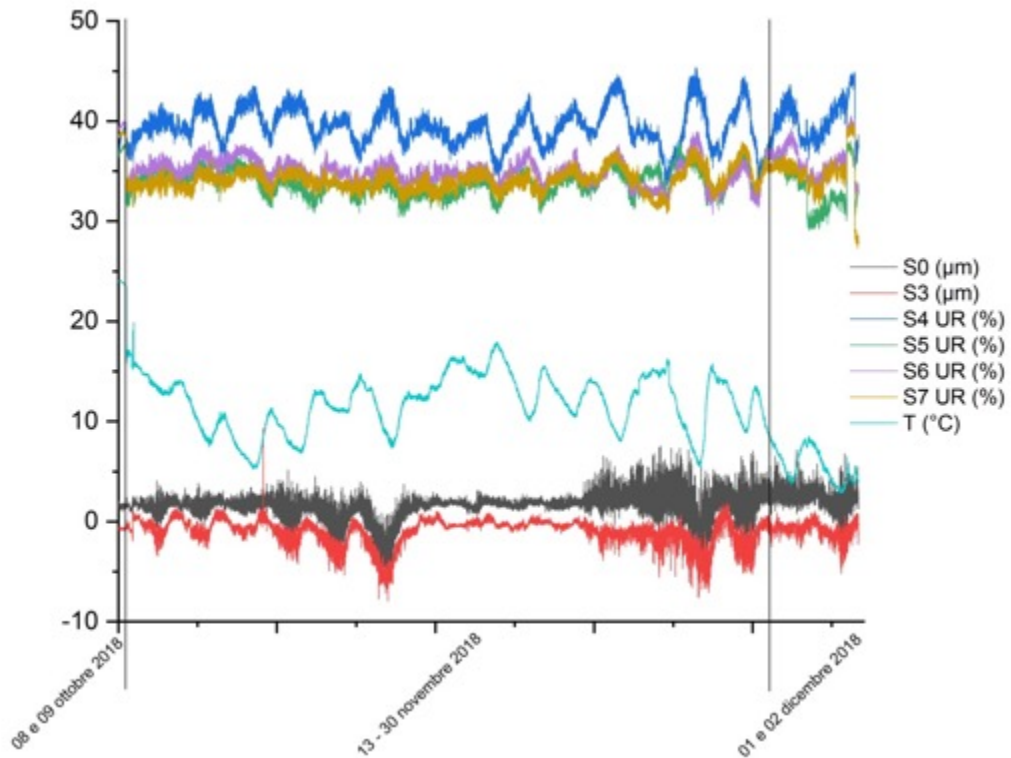
Figure 37 Trend of the values recorded in Michelangelo's Cloister (october-december 2018)

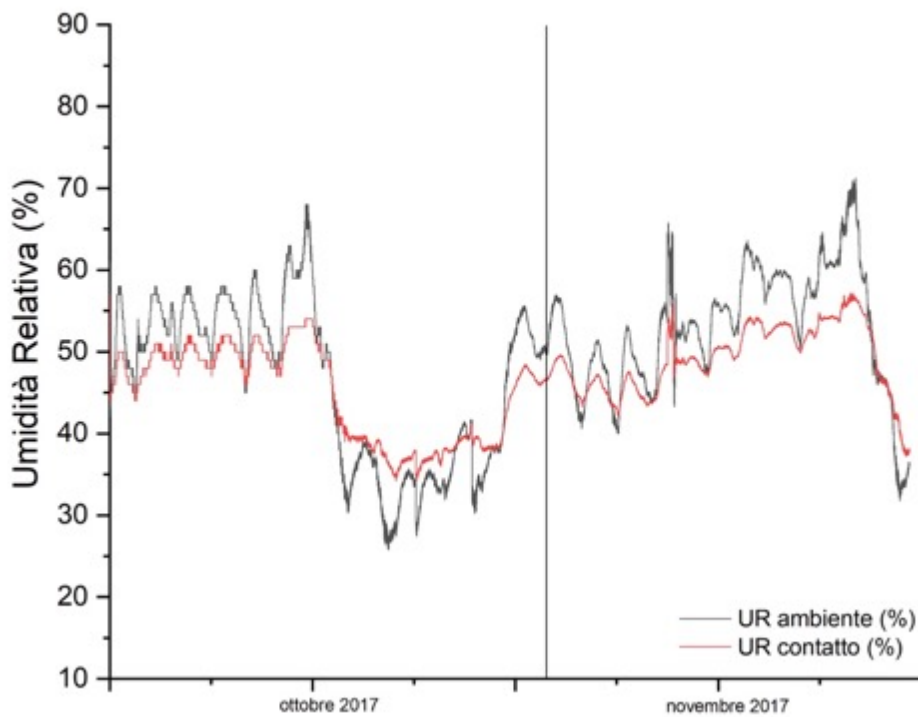
Figure 46 Trend of humidity value by Arduino sensor, October - November 2017.

The graphs show the trends of both environmental and contact humidity recorded during the years 2017, 2018, 2019. The values of contact humidity, generally around 45-60%, show a trend similar to that of the environmental humidity which generally has values 5-10% higher. This can mean that in the masonry area investigated percolation or rising humidity does not produce stagnation. The increase of environmental humidity is due to the climate changes and variations. Probably, since the hall is not an isolated environment, the humidity comes from the ground, by rising damp, and from the external environment. The trends recorded, for the entire period under investigation, are not good for a proper conservation. As already written, a lower level of humidity can cause the production of salt efflorescence, otherwise a higher level of humidity argillification and more generally changes in the nature of the building material. The pressure inside the lesion of masonry is measured inserting in it for some centimetres the FlexiForce sensor, which allows to monitor the stress of the masonry since during its contraction the two inner faces of the wall press on the sensor thus giving a percentage value recorded by the Arduino. During the monitoring period, there were, in particular in the months of November and December 2018, February March 2019, quite significant masonry stress, in terms of expansion or contraction of the investigated lesion. This kind of movements can be dangerous for the preservation of the structure and must surely be kept under control, since they can cause worsening of the lesions and loss of the stability of the wall.

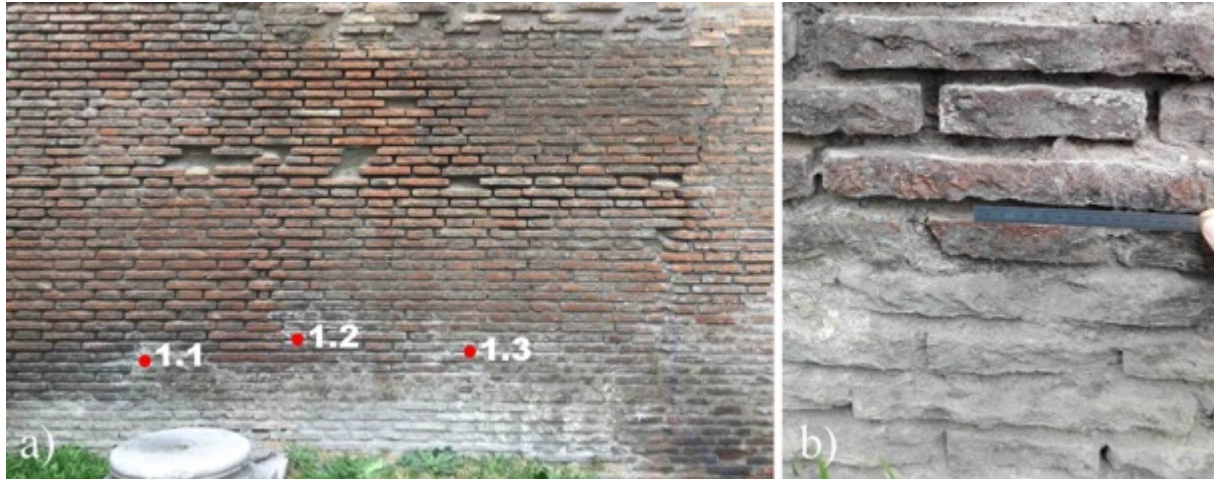
**Figure 71 (a) Sampling points of the external wall with minimal presence of efflorescence. b) detail of wall bricks.**

For soluble salts analysis, efflorescences were taken from the surface of the external and internal wall of the Hall I. Due to atmospheric conditions and by gravity the superficial crystallizations on the outside wall are easily lost, for this reason, for having a sufficient sample for the analysis, the salts were taken from three different points (fig. 24a), thus with an average value for the masonry.

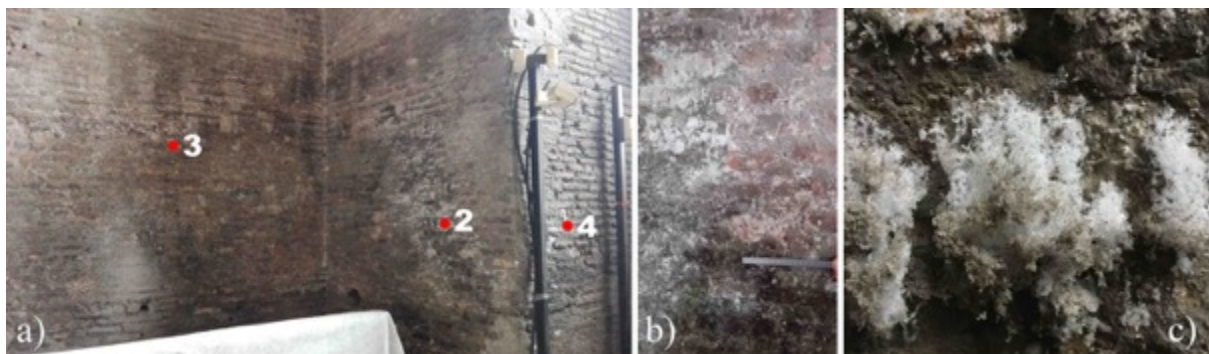
**Figure 72 (a) Points of the masonry inside the Hall I where the samplings were made (b) Detail of the masonry and (c) of the salt efflorescences.**

Inside, the samples were taken in three points, one for each part of the masonry investigated with FBG optical fibre (figure 24a). The slow thermo-hygrometric variations, due to the closure to the public of Hall I, allowed dissolved salts to migrate to the surface by the capillary effect of the water, and crystallize in long beards (figure 25b-c).
